ISSN 0554-6397
Stručni članak
(Professional paper)

Alveus d.o.o., Delta 3, 51000, Rijeka, Croatia

Study of Tube And Tank Specimens Repaired Using a Carbon Fibre Reinforced Epoxy

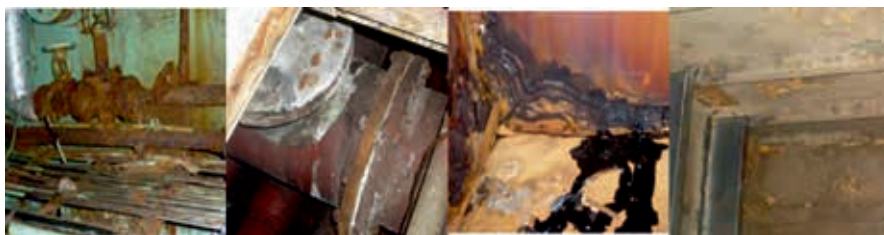
Figure 1: Frequent problems of corrosion and cracks on various positions on different vessels

Merchant and passenger vessels, such as tankers or bulk carriers, operate in harsh environments, enduring corrosion and cyclic force and thermal loads that lead to various forms of vessel damage and defects as presented in Figure 1, endangering people and cargo, as well as posing a risk to the environment in some cases.

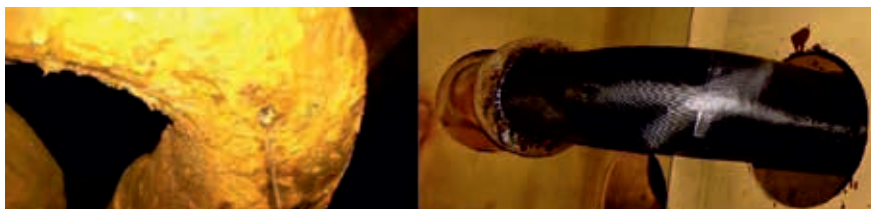
Figure 2: Steel tube before (left) and after the repair (right)

In such situations, each ship-owner or operator company seeks an effective and fast repair solution in order to: reduce potential risks, assure alignment with the international maritime regulations and minimize the time delays to its ships, which leads to a loss of revenue if a ship is taken out of service for a repair by traditional approach of steel cutting and welding. Such approach requires redirection of a vessel to a shipyard resulting in substantial vessel downtime, which results in mentioned loss of revenue and also large expenses for a repair. The traditional approach requires a replacement of a part of ship structure, even when a problem is present only in a small section. In addition this method requires the removal of parts, equipment or ship interior details, leading to greater expense and additional downtime to execute the repair. Most importantly, the welding cannot be applied in all areas of a ship since some locations are adjacent to fuel tanks and pose a potential fire risk, causing a cutting and welding procedure to be dismissed if fuel tanks are not emptied and properly cleaned before the repair. In such cases, a bonded patch repair based on fibre reinforced polymer (FRP) is a potential cost and time efficient repair solution [1]. This solution utilises fibres mixed with polymer resin. By curing, the resin hardens and bonds the fibres to the damaged surface permanently and the resulting composite material patch reinstates the damaged material's strength and provides water tightness; see Figures 2 and 3 for more information.

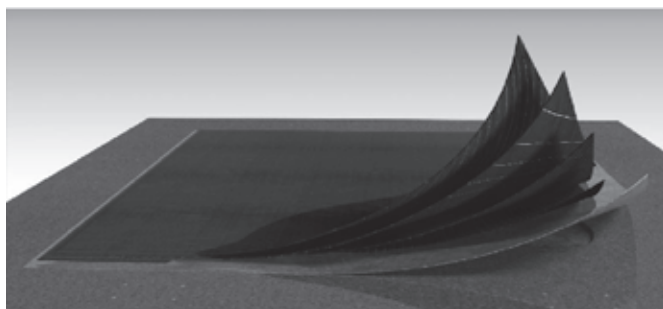
Figure 3: Schematic composite patch layout

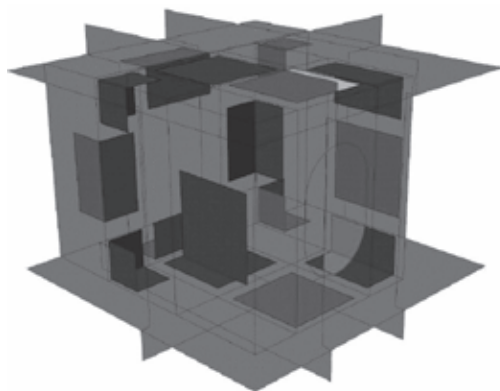
Figure 4: Schematic representation of the tank specimen (I – patch on the inner side (magenta); O – patch on the outer side (green))

Two specimens were modelled and analysed. The first one is a steel tank being repaired using 16 composite patches (8 inside and 8 outside of the tank) subjected to the internal pressure of 3 bar; see Figure 4 for a schematic representation and accurate drawings in Figure 5.

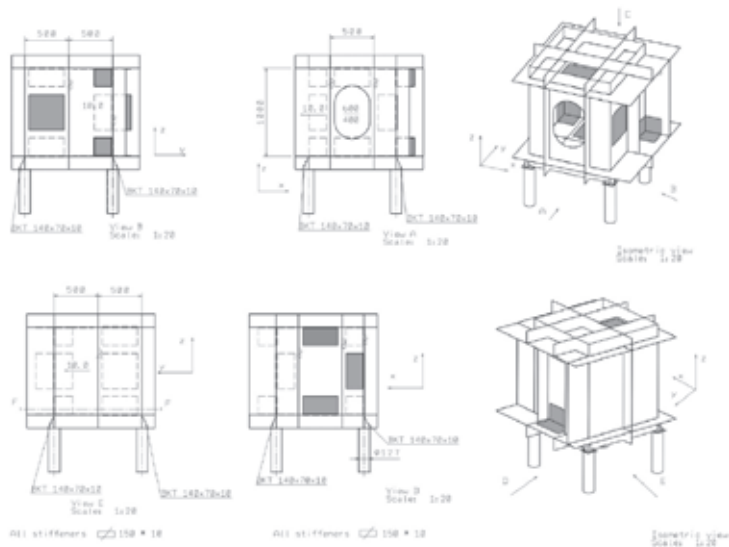
Figure 5: Drawings of the tank specimen

The tank specimen has overall dimensions of 1.6x1.6x1.3 m. The geometry can be seen in Figure 5 and 8, where composite patches are denoted in Figure 8 by magenta colour for inner patches and by green colour for patches on the outer side of the tank. The pressure of 3 bar was applied in the inner side of the tank dimensions 1x1x1 m; see Figure 10.

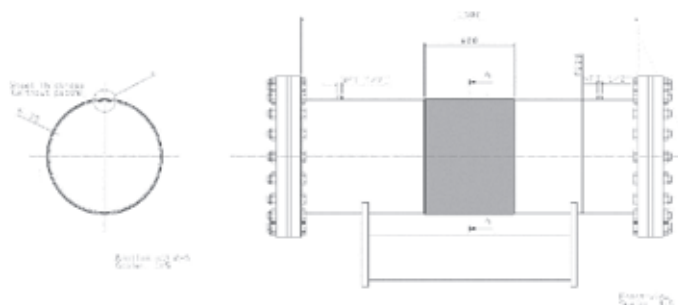
Figure 6: Drawings of the pipe specimen

Each of the 16 patches is used to repair a small circular hole, which has an area of 1 cm^2 and is located exactly in the middle of the patch. Therefore, depending of the patch, some holes are located at the flat plating and some are located at the intersection of two or three flat plates. The second specimen is a steel pipe with one composite patch analysed under pressure of 15 bar and is presented in drawings in Figure 6. There is the same size small-hole in the middle of the patch within the pipe specimen as well. Both analyses were conducted in Ansys 19.2 APDL software.

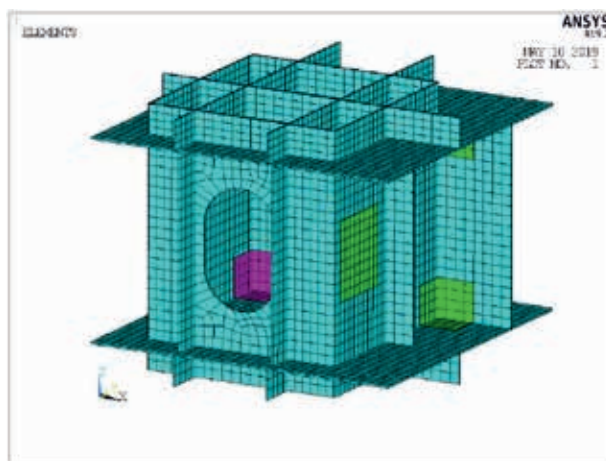
Figure 8: FE model of tank with patches

For both models, the structure and composite patches are discretised by 8-node structural shell elements SHELL281 with element size of 50 mm. This type of element is suitable for layer-type of modelling a composite material. The steel is modelled as isotropic elastic material with Young's modulus of 210.000 MPa and Poisson's ratio of 0,3. The default element edge size is 45 mm in this study.

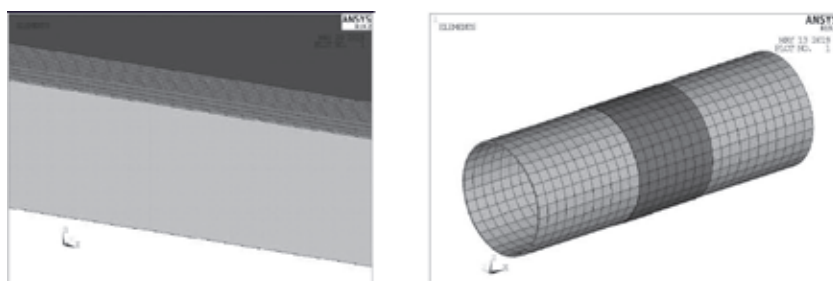
Figure 9: Left: Detail of layered elements in part of tank structure with inner patch (blue represents steel, orange represents adhesive and magenta composite layers); Right: FE model of the pipe with the patch

Steel structure of tank has a thickness of 10 mm, and adhesive (Epoxy resin) has thickness of 0.2 mm. All layers in the model can be seen on the left side of Figure 9.

Regarding the model of pipe, composite patch has the same layup as in the tank model, but the steel structure has a thickness of 6.35 mm which is a standard thickness for pipe DN500 that is certified for the pressure of 15 bar. FE model of the pipe structure with composite patch is shown on the right side of in Figure 9.

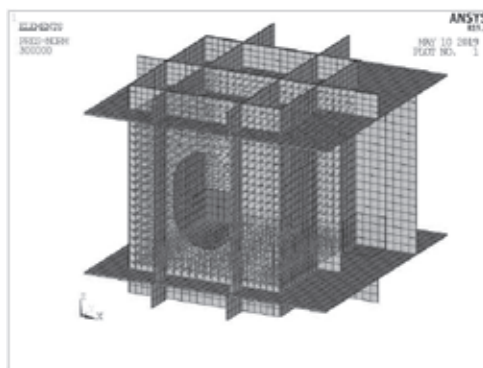
Figure 10: Applied pressure load of 3 bar to the tank interior

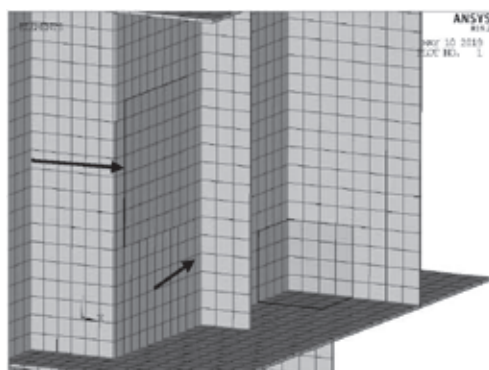
Figure 11: Left: Applied force load of 30 N to the middle node of the external patches

In order to simulate hole in the steel plate, a force of 30 N was applied in one node in in the middle of the external (green) patches; see Figure 11. The force of 30 N corresponds to the pressure of 3 bar acting on the hole-area of 1 cm².

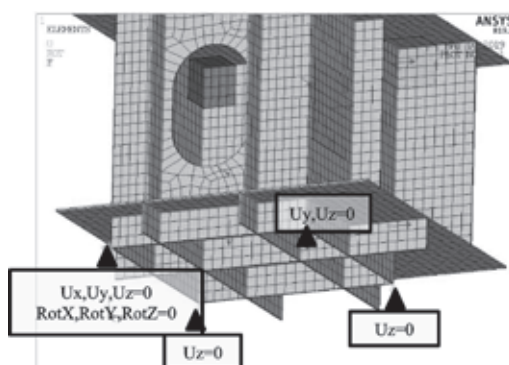
Figure 12: Left: Applied boundary conditions

The model boundary conditions for both load cases are shown in Figure 12.

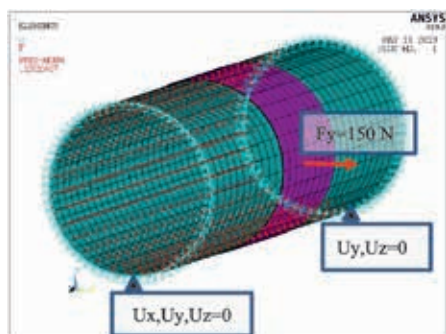
Figure 13: FE model of the patched pipe specimen showing pressure and boundary conditions

Standard steel DN500 pipe with length of 1.5 m and thickness of 6.35 mm was analysed. Composite patch with length of 400 mm was placed in the middle of the outer side of the pipe and around the entire pipe diameter. The geometry can be seen in Figure 13, where the composite patch is depicted by magenta colour.

Patched pipe was analysed under pressure of 15 bar. The pressure was applied in the inner side of the pipe (see Figure 13). In order to simulate crack / hole in the steel part, a force of 150 N was applied in one node in the middle of the patch. The force corresponds to the pressure of 15 bar acting on the hole of 1 cm². Boundary conditions are also shown in Figure 13. On one side of the pipe, displacements in all directions are suppressed and on the opposite side, displacements only in y and z direction are suppressed.

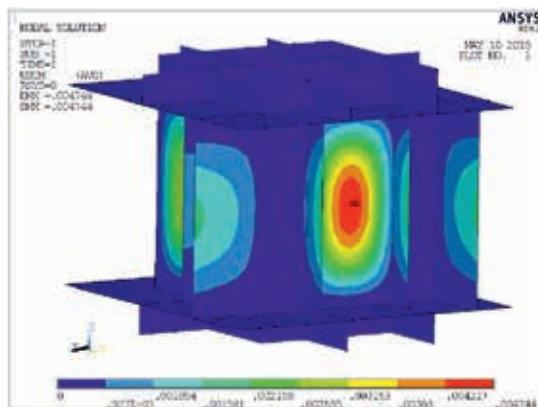
Figure 14: Displacement vector sum in m

The results of the analysis show that the total displacement is 4.7 mm in the middle of the red coloured area shown on the side of the specimen in Figure 14.

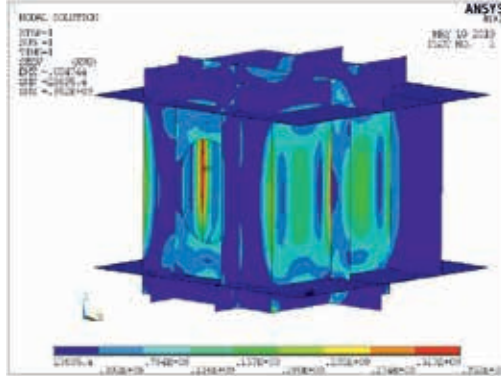
Figure 15: Von Mises stress plot

Maximum von Mises stress in steel structure is 352 MPa (see Figure 15) that occurs in the area of weld between vertical plates and stiffeners, i.e. in the junction of plates and stiffeners. This is an unrealistic concentration of stress in nodes which can be neglected because the weld area was omitted from the model.

The remaining structure has a Von Mises stresses well below the maximum permissible value of 282 MPa. The maximum permissible von Mises stress for steel is 282 MPa and it was calculated according to DNV-GL Rules for classification, Pt3 Ch7 Finite element analysis. There, the maximum permissible stress is calculated according to the fine mesh yield utilisation factor .

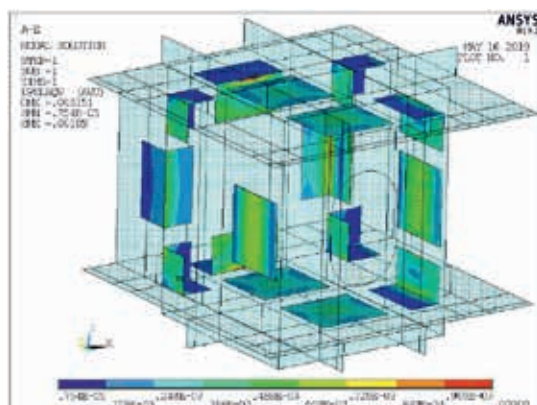
Figure 16: Von Mises strain plot

Regarding the adhesive layer between steel structure and the composite patches, the results show that stresses and strains are far from the breaking limits given by the manufacturer for the West System Epoxy Resin 105 used here as the adhesive material. For the simplicity, only the strains were given here in Figure 16.

Maximum von Mises elastic strain in adhesive is only about 0.1%, which is far from the breaking limit of 3.5%, indicating that the adhesive is safe from breaking.

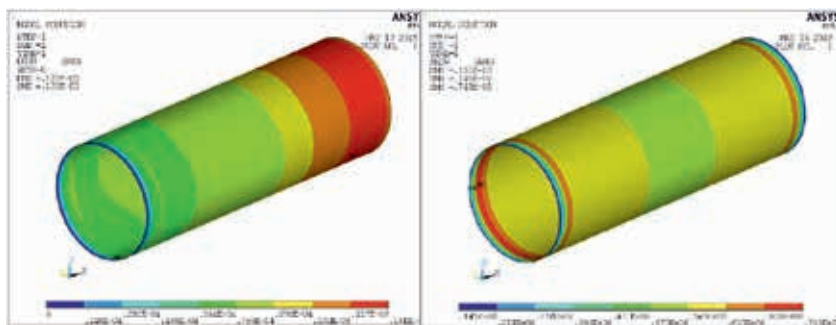
Figure 17: Left: Resulting displacement vector; right: Von Mises stress plot

The response of the steel material of the pipe specimen shows that the total displacement is 0.13 mm, whereas the maximum von Mises stress is 74.3 MPa (see Figure 17).

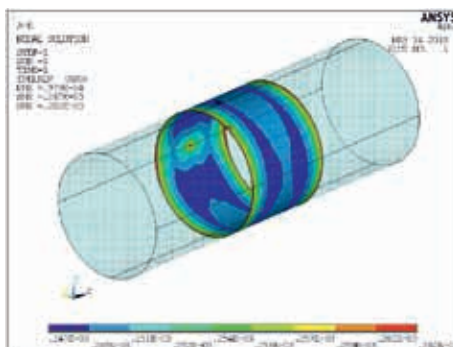
Figure 18: Von Mises strain plot

The stresses and strains are far from the breaking limits in the adhesive layer; see Figure 18 for the strain plot.
